Plumbing System

CLIENT ADVISORY

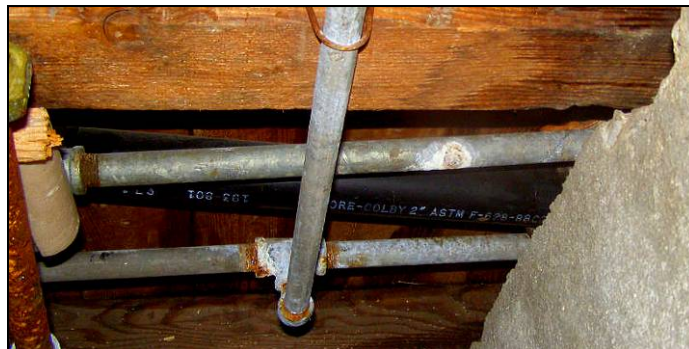
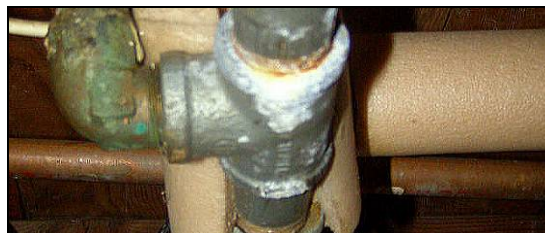
Interior Water Supply Piping

There was evidence of surface corrosion, but no leakage, at the exposed and accessible supply piping. This piping should be monitored for leakage and repaired if necessary.
